Improved crop health and  
reduced irrigation system  
maintenance for a vegetable  
farm in the Almeria region,  
Spain

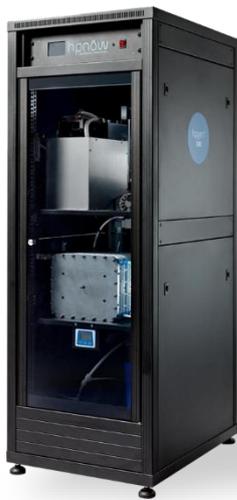
With HPGen, water treatment can be implemented in a simple and efficient way. HPGen A series is designed specifically for the agriculture market and integrates seamlessly with standard irrigation systems. HPGen produces a safe concentration of a peroxide-based oxidizer solution. This powerful solution is injected into irrigation lines, where it keeps emitters flowing and enriches the water with oxygen. This ensures an optimal irrigation uniformity, increased nutrient availability and higher yields.

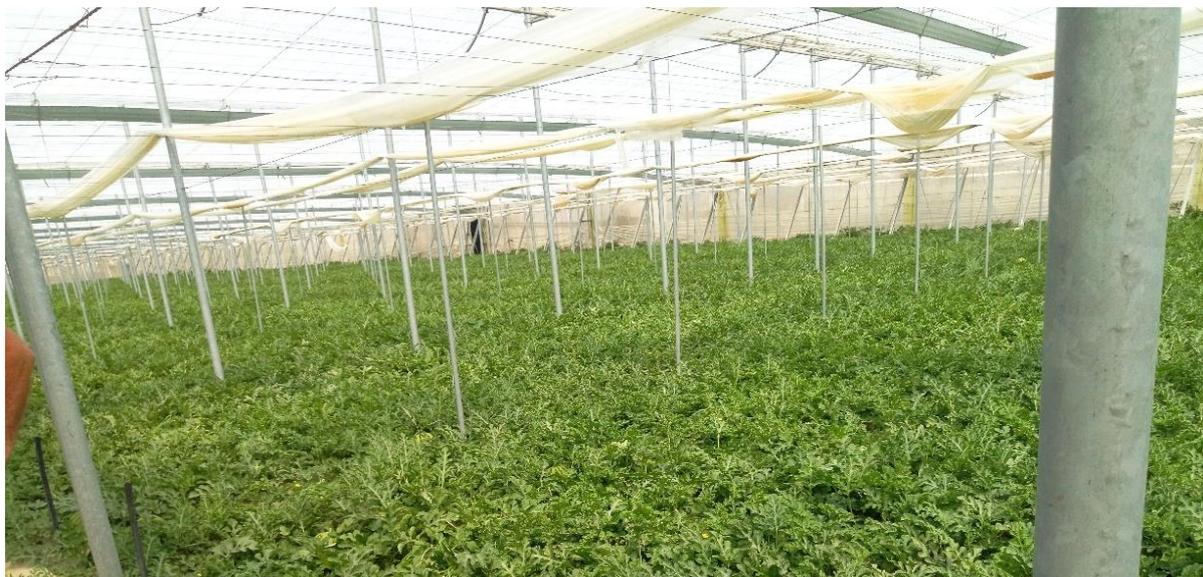
The HPGen A500 was installed in the irrigation room and set to operate automatically with a reservoir. Prior to installation, the drippers were analyzed, and a large proportion were clearly clogged, meaning little to no water was coming through them. To overcome this, the farm personnel were going through the drippers frequently to “unclog”, a manual process highly costly in man-hours.

Dosing: The HPGen was set to produce a 0.15% Hydrogen Peroxide solution in a buffer tank which was then diluted in-line for the irrigation water.

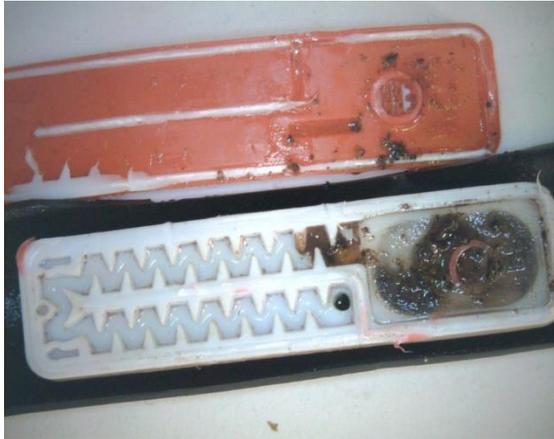
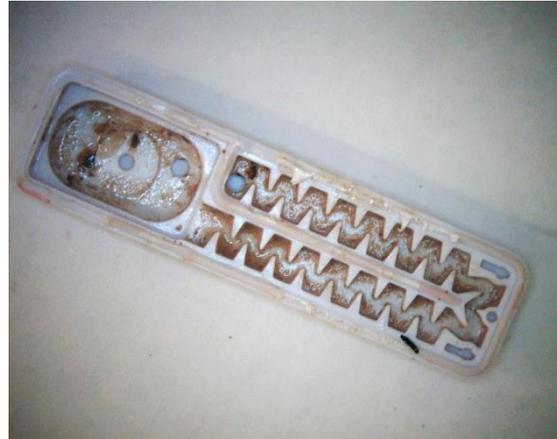
After just six months of running with the HPGen, soil quality was analyzed once more and found to be greatly improved. The results indicated more than ten-fold improvement in organic matter. At the same time, the drippers now exhibited no clogging. See images below of dripper before and after using HPGen:

The benefits are clear, a more efficient irrigation system where maintenance of the drip lines has been eliminated and delivery of fertilizer optimized. The plants from the treated section could be directly compared to a section without treatment, where all other parameters were kept the same as the section treated with HPGen.
