## Improving crop health and reducing irrigation system maintenance for berry farm in Skælskør, Denmark

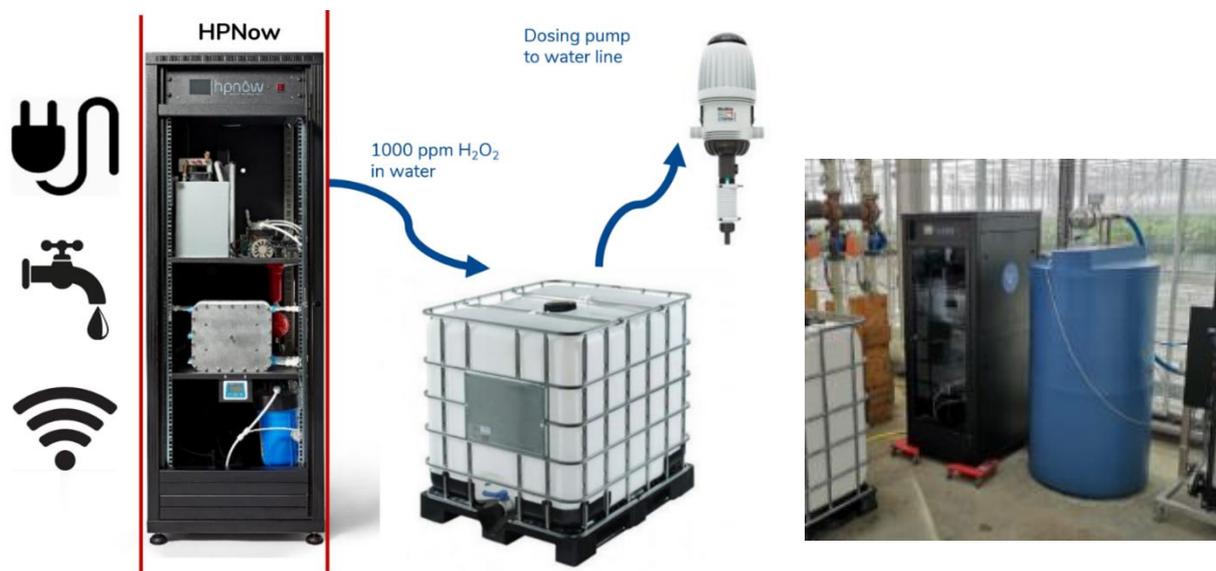
The HPGen A500 was installed in the irrigation room and set to operate automatically with a buffer tank. Prior to installation, the drippers were analyzed, and a large proportion were clogged, meaning little to no water was coming through them. To overcome this, the drip system would normally have to be replaced between seasons.

Dosing: The HPGen was set to produce a 0.1% high-purity peroxide solution in a buffer tank from which the solution was dosed into the irrigation line. The in-line concentration was checked by measuring the peroxide concentration coming out of the drippers.

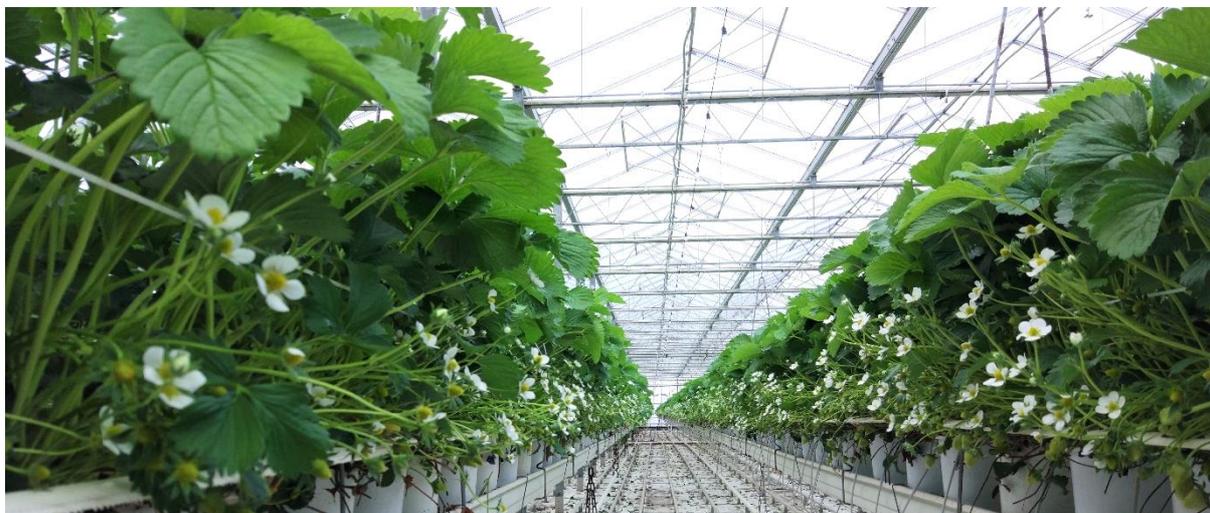
HPGen was installed to treat a section of the greenhouse so the grower could compare to a non-treated section.

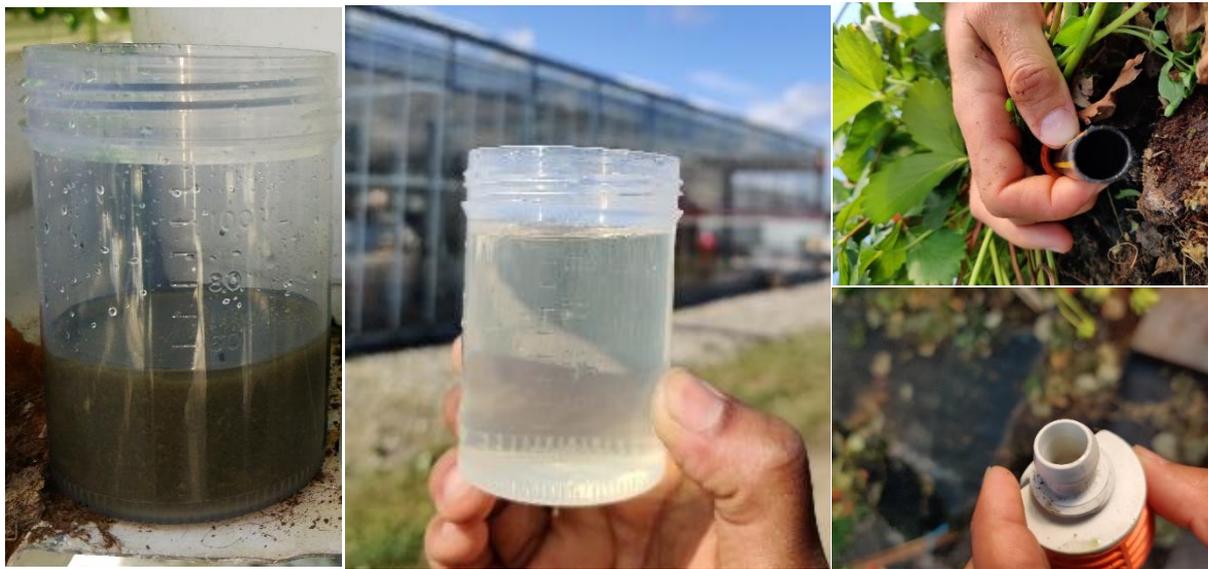
After running with the HPGen for a season, the treated drippers exhibited virtually no clogging, whereas the untreated section had the same performance as before with clogging and non-uniform irrigation. The benefits are clear, a more efficient irrigation system where maintenance of the drip lines has been eliminated and delivery of fertilizer optimized. With these results, dripper lifetimes can be greatly extended, plants remain healthy throughout the season and stand a better chance fending off attacks from pests, diseases or fungi. From tubing to water exiting the drippers, the system could be maintained in a clean state.

1 Before treatment

2 After treatment
