Improved crop health and
reduced maintenance for an
organic blueberry farm in the
Huelva region, Spain

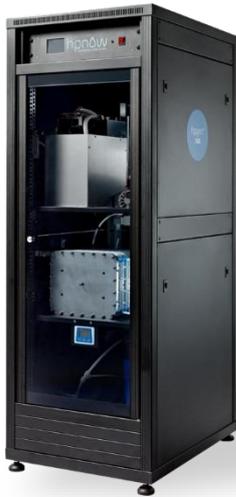
With HPGen, water treatment can be implemented in a simple and efficient way. HPGen A series is designed specifically for the agriculture market and integrates seamlessly with standard irrigation systems. HPGen produces a safe concentration of a peroxide-based oxidizer solution. This powerful solution is injected into irrigation lines, where it keeps emitters flowing and enriches the water with oxygen. This ensures an optimal irrigation uniformity, increased nutrient availability and higher yields.

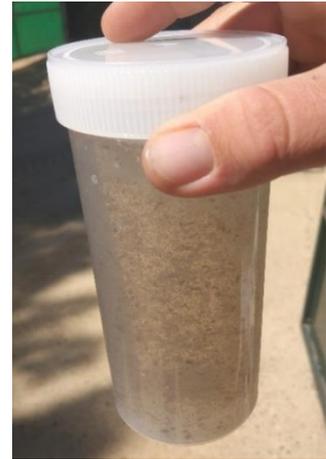
1. Clogging of drippers leads to non-uniform irrigation and insufficient water and fertilizer delivery to part of the crop, which results in production losses.
2. Poor dissolution of organic fertilizer in the irrigation water leads to poor soil quality, exacerbates clogging and hampers growth.

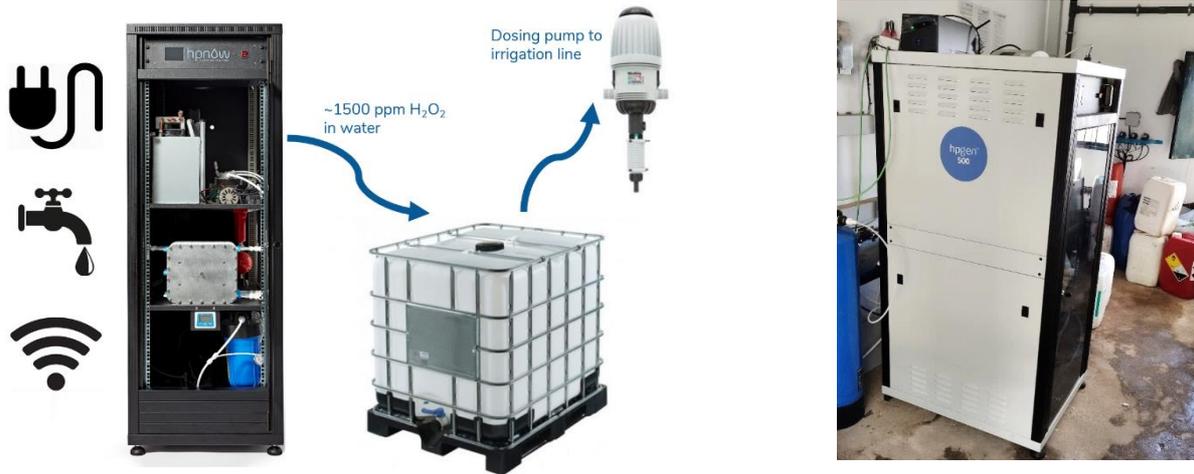
The HPGen was set to produce a 0.15% high-purity peroxide solution in a buffer tank.

The HPGen A500 was installed in the irrigation room and set to operate automatically with a reservoir. Prior to installation, the drippers were analyzed, and 30% were clearly clogged, meaning little to no water was coming through them. To overcome this, the farm personnel were regularly going through the irrigation lines to identify and replace clogged drippers, a time-consuming and costly process.

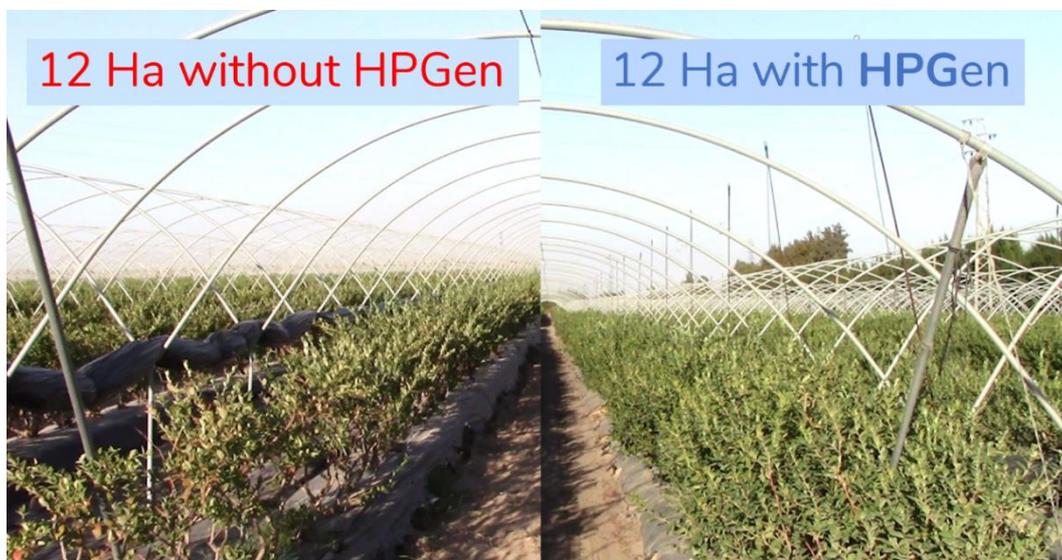
After just six weeks of running with the HPGen, soil quality was analyzed once more and found to be greatly improved. The results indicated near three times higher organic matter content. At the same time, all drippers in the treated section were unclogged vs. about 30% of drippers clogged in the untreated section. The benefits are clear, a more efficient irrigation system where maintenance of the drip lines has been eliminated and fertilizer delivery optimized. The plants from the treated section could be directly compared to a section without treatment, where all other parameters were kept the same as the section treated with HPGen.

"In the non-treated sector, the plants are smaller, and the sprouting is substantially smaller than in the sector treated with HPGen"

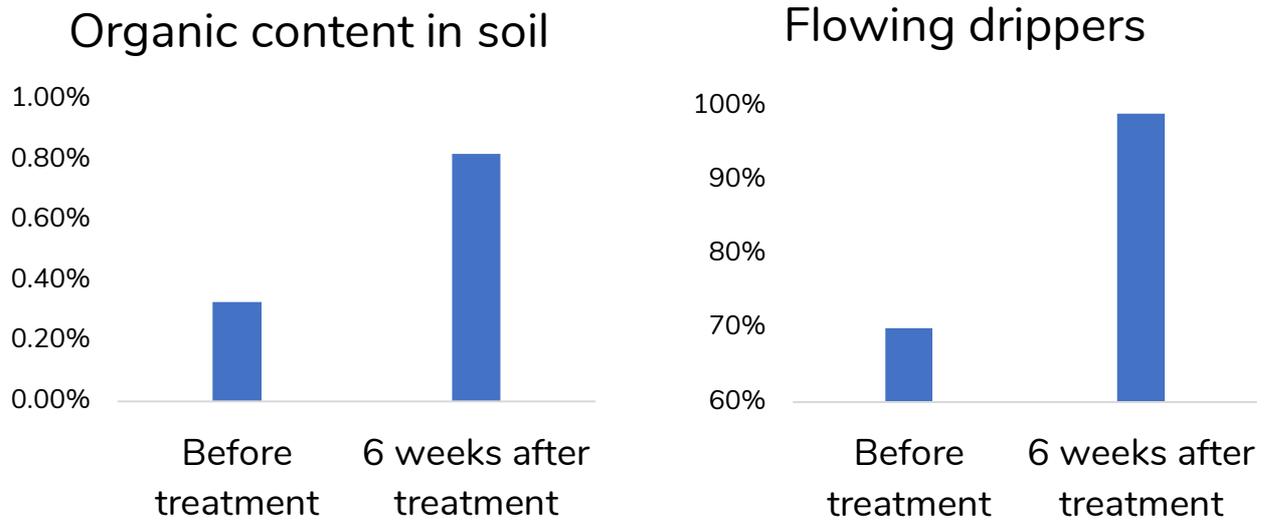
The results for soil analysis and investigation of drippers can be seen below:
