HPGen improves post-harvest biosecurity in melon packing house

Crop	Unit type	Irrigation system	Results
Melons	2xHPGen A3000	-	<ul style="list-style-type: none"> Improved sanitation of melons post-harvest Residue-free treatment of melons in closed-loop water recirculation system

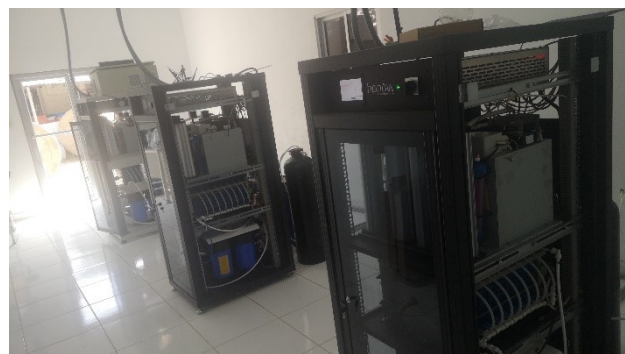
HPGen production center at Agrolíbano, composed of three HPGen A-Series systems.

Agrolíbano installed three HPGen A-Series systems in its packing house. Peroxide UltraPure™ generated by the systems is introduced in a controlled manner in the recirculating water baths used in the melon cleaning process.

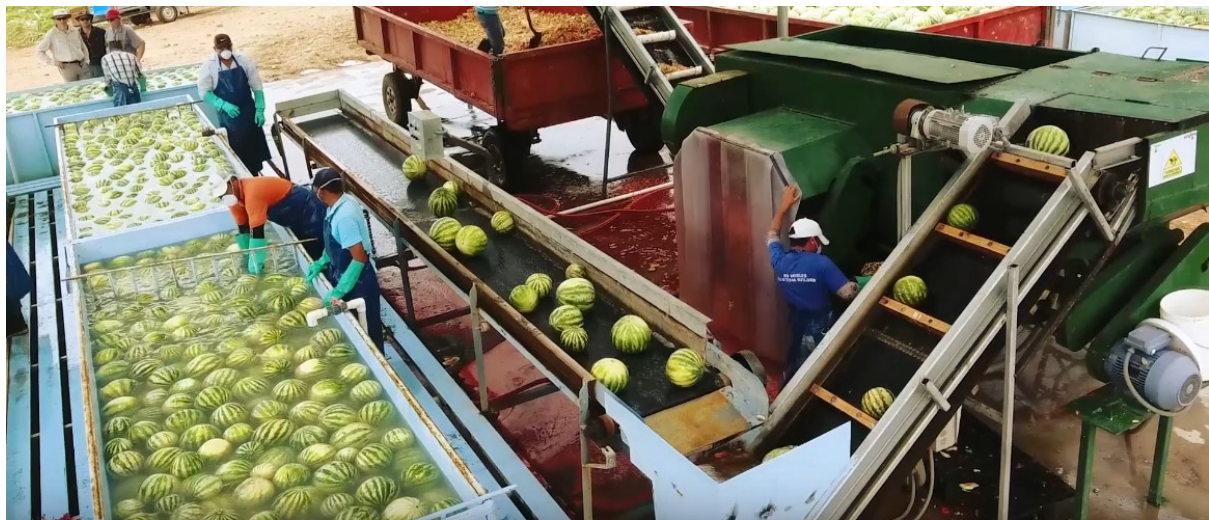
Post-harvest cleaning of the fruits at Agrolíbano.

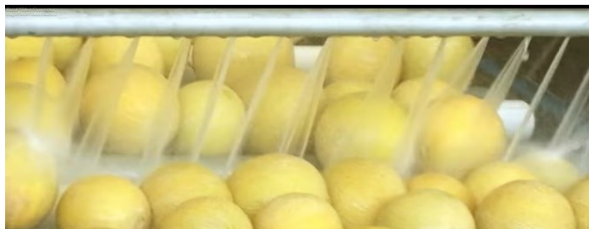
Detail of the melon wash process, and image of the packing house. Water used in the process is recirculated, and contains Peroxide UltraPure™ that keeps it clean.

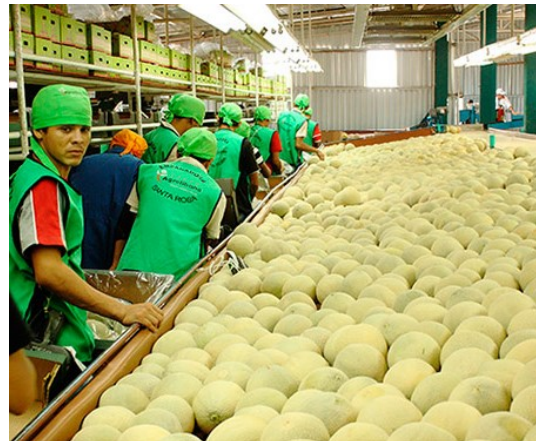
HPGen setup

The HPGen systems were installed in a dedicated room and set to automatically fill a buffer tank with Peroxide UltraPure™. Dosing was done manually. The system operates completely autonomously, without need for user intervention. Peroxide UltraPure™ is generated at a concentration of 0.25%, which is very safe and poses no danger to humans, plants or equipment, but is strong enough to effect the desired operational results.
